ENGINE PERFORMANCE OF OVERTEMPERATURE HEAT-TREATED S-816 BUCKETS

By R. A. Signorelli, F. B. Garrett, and J. W. Weeton

March 2, 1956
Declassified February 8, 1957

NACA RM E55L06a

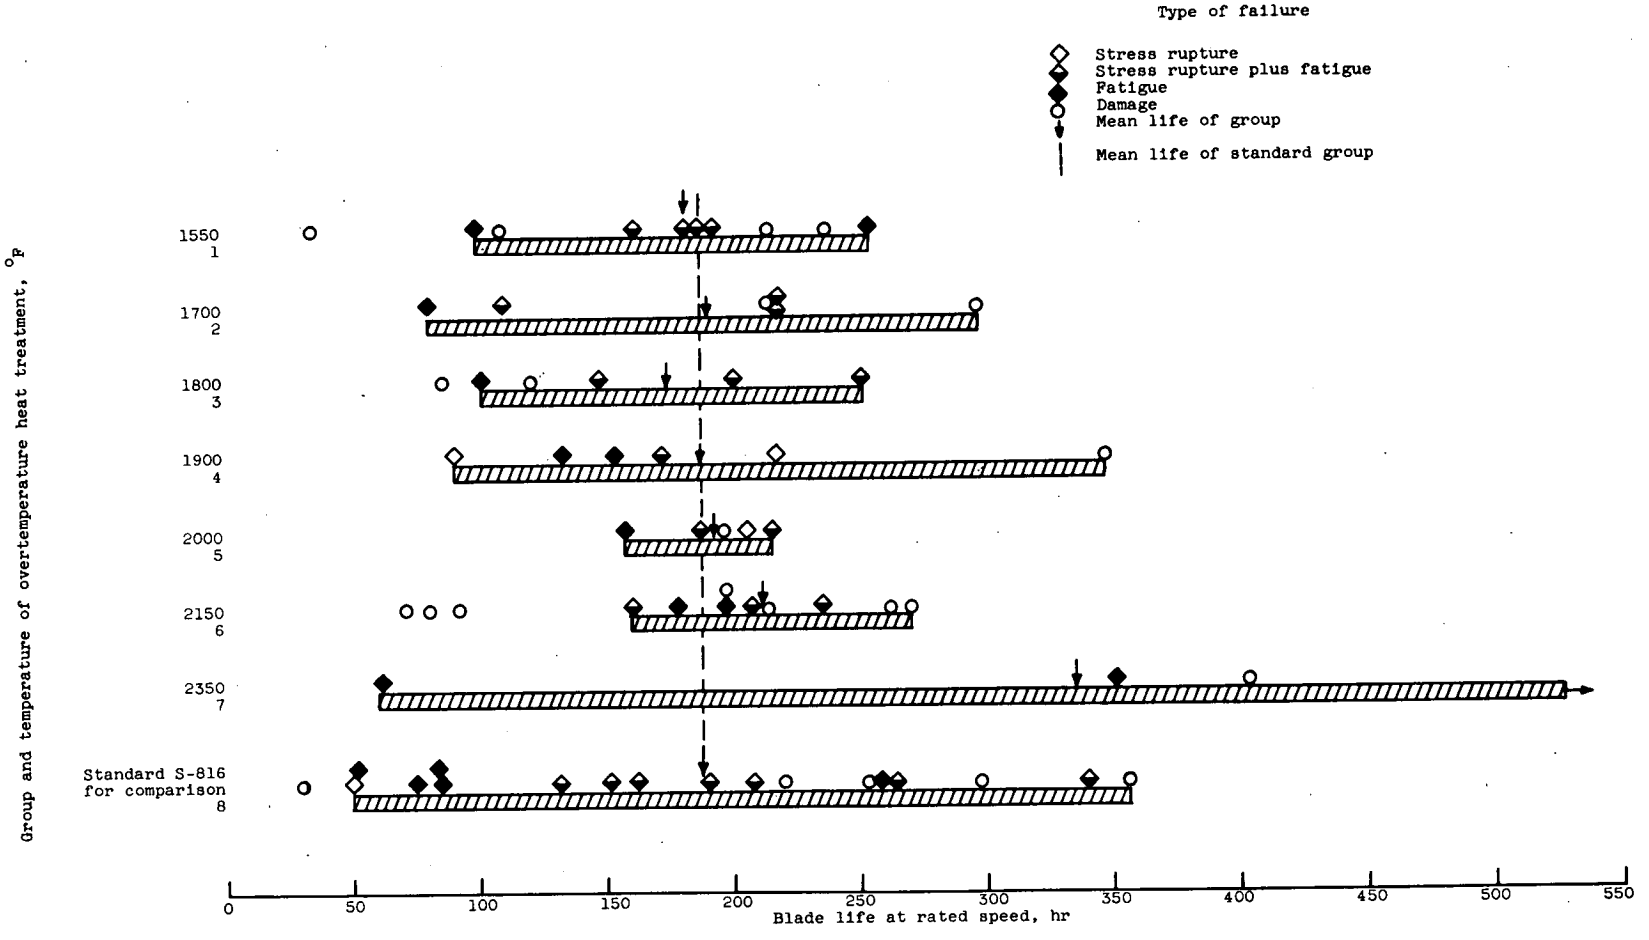
Engine results. - The engine results are presented in figure 2 and table I. Buckets overtemperatured in the range of 1550° to 2150° F (groups 1 to 6) ran about as long as the standard S-816 group. Buckets overtemperatured at 2350° F (group 7) ran longer than the standard group. Mean life of the standard buckets, group 8, was 188 hours. Mean life of overtemperatured groups 1 to 6 ranged from 175 to 212 hours. Mean life of overtemperatured group 7 buckets was at least 336 hours; one bucket did not fail in 527 hours. The failures, excluding failure by damage, were classified by visual examination as follows: stress rupture, 9 percent; stress rupture plus fatigue, 56 percent; and fatigue, 35 percent.

Figure 2. - Engine results.

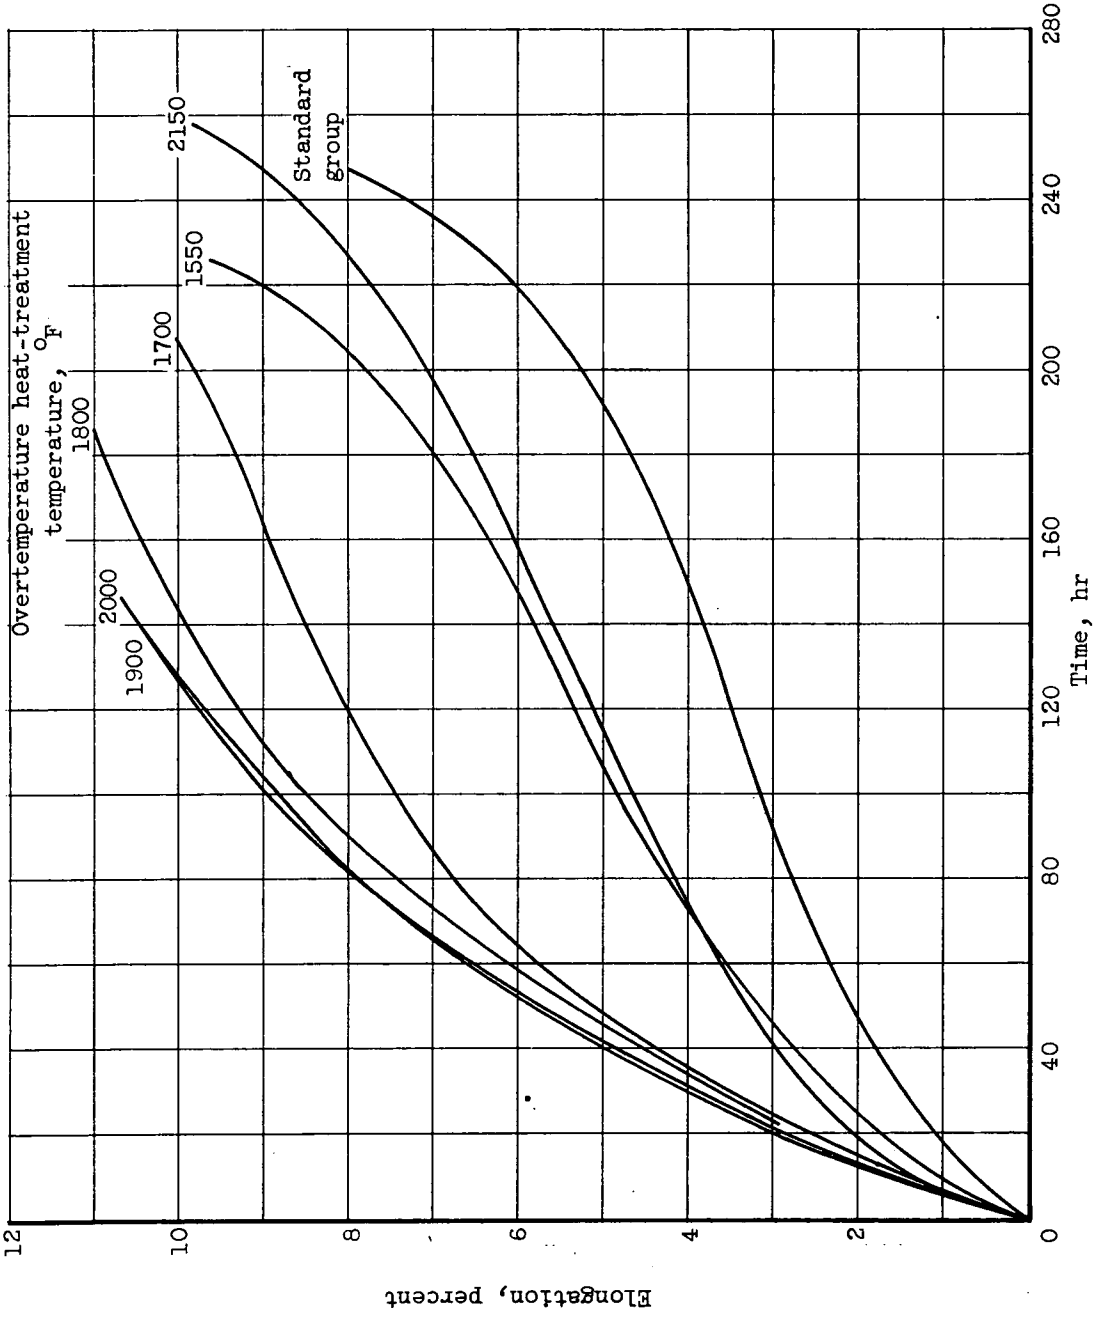
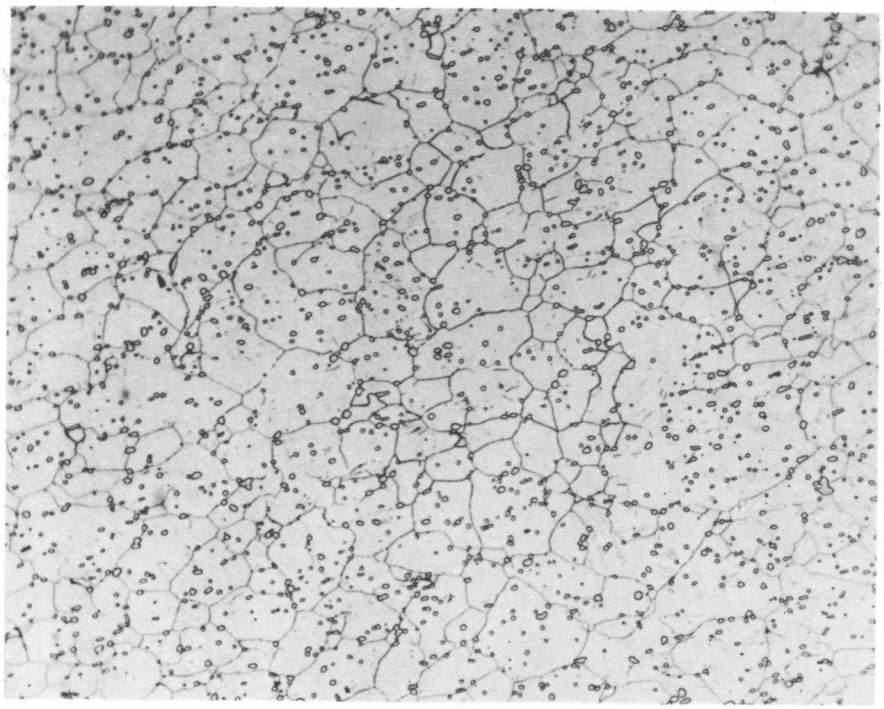
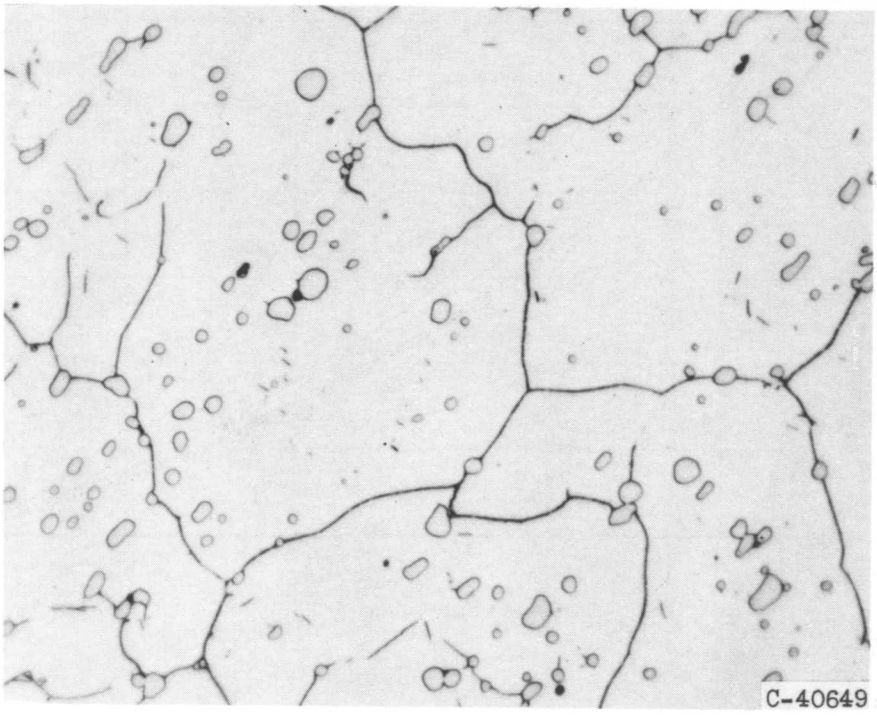
Elongation. - Elongation measurements for groups 1 to 6 and the standard group are shown in figure 3. Measurements were taken on two buckets of each group; data from the bucket with the greater elongation of each group was plotted. Only the values for zone 2 are plotted because this zone showed the greatest elongation. The final values measured ranged from 8 to 11 percent, a rather narrow spread of values. The narrow spread is in part due to the fact that the final measurements take no account of the total ultimate elongations just prior to fracture. The rates of elongation may be used to determine the relative stress-rupture damage resulting from the overtemperature treatments. The rate of elongation (creep) increased with increasing temperature for the temperatures ranging from 1550° to 2000° F (groups 1 to 5). The blades overtemperatured at 2150° F (group 6) had a creep rate slightly lower than that of the 1550° F group. All overtemperature heat-treated groups shown had elongation rates appreciably higher than that of the standard group.

The 2150° and 2350° F treatments, however, are solution treatments rather than over-aging treatments, as indicated in figures 10 to 13. Precipitation of minor phases during engine operation probably strengthened the materials so treated and increased creep resistance. The elongation curves of figure 3 for the 2150° F treatment buckets are in agreement with this. Unfortunately, elongation data for the 2350° F treatment buckets were not obtained.

Figure 3. - Elongation of zone 2 during engine test.

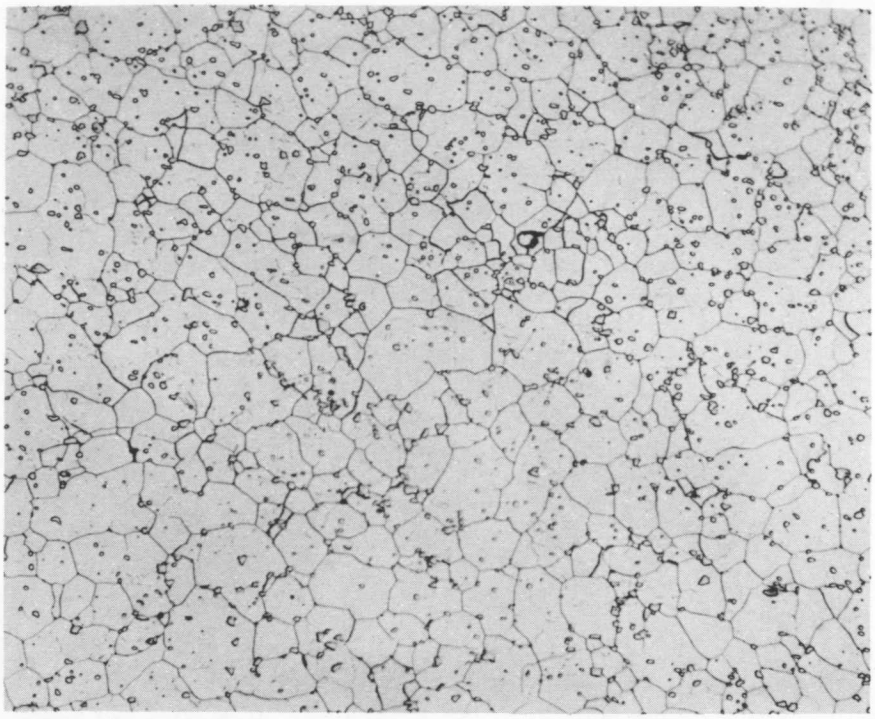
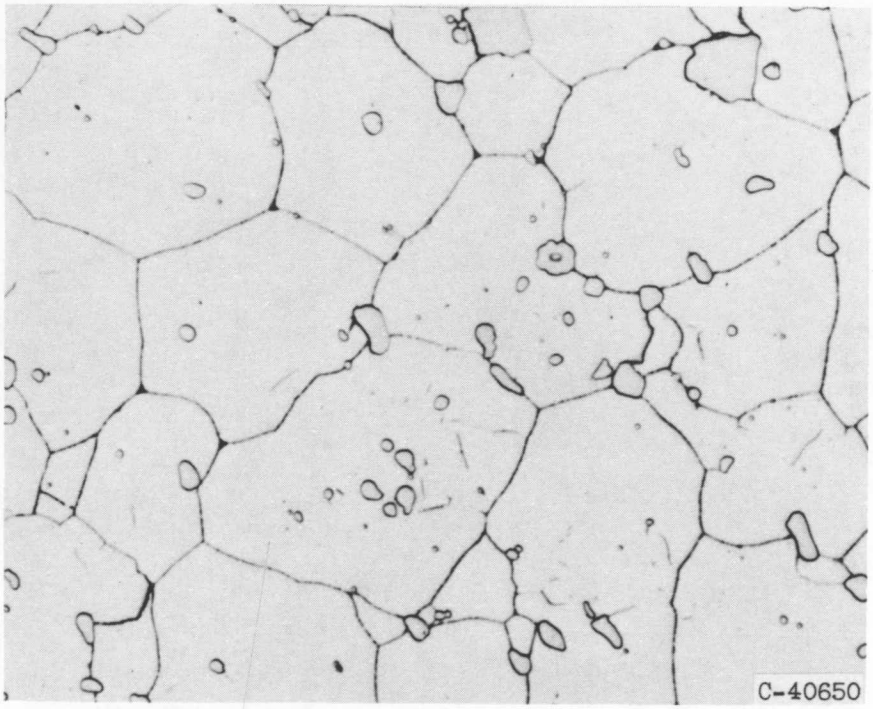
Microstructure. - Photomicrographs of standard and as-overtemperatured S-816 structures are shown in figures 4 to 13. These figures show the microstructures produced from the slight over-age at 1550° F to complete solution of grain-boundary precipitates at 2150° and at 2350° F. There is indication of slight spheroidization of grain-boundary precipitates with the 1550° F treatment. Agglomeration and spheroidization of the precipitates increased with increasing temperature from 1700° to 1900° F. At 2000° F, the precipitates began to dissolve. The 2150° and 2350° F treatments dissolved all precipitates except the massive, stable (Cb, Ta)C. There was evidence of eutectic melting in the specimens heat-treated at 2350° F, although it is not shown in the photomicrographs. The over-etched structures shown in figures 11 and 13 reveal the grain boundaries and grain size of the solution-treated structures that were not visible when the same specimens were etched normally (figs. 10 and 12).

Figure 4. - Microstructure of S-816 after standard heat treatment. Etchant, 25 percent aqua regia plus 75 percent glycerol.

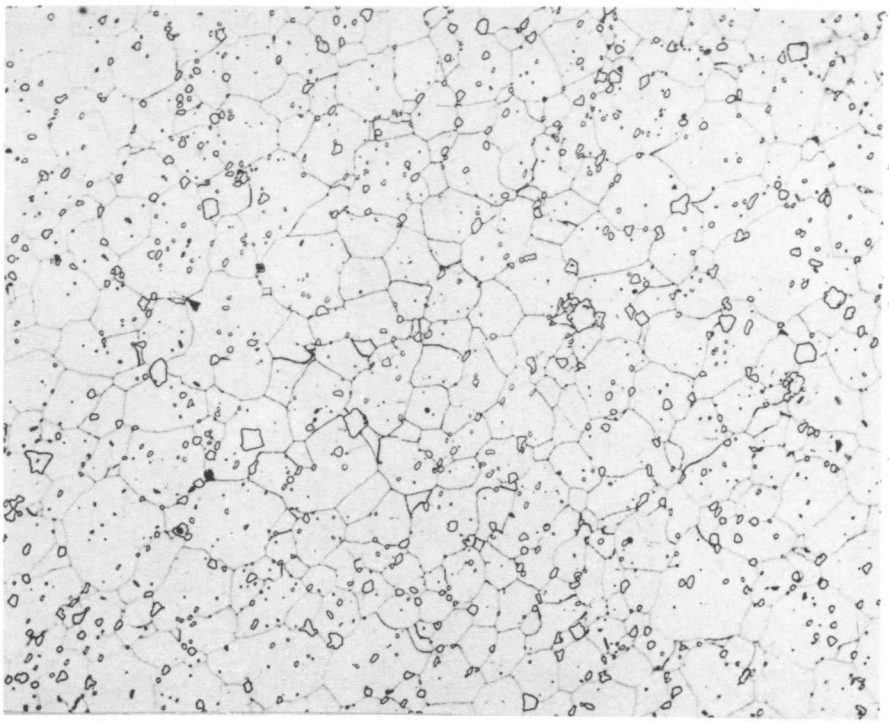
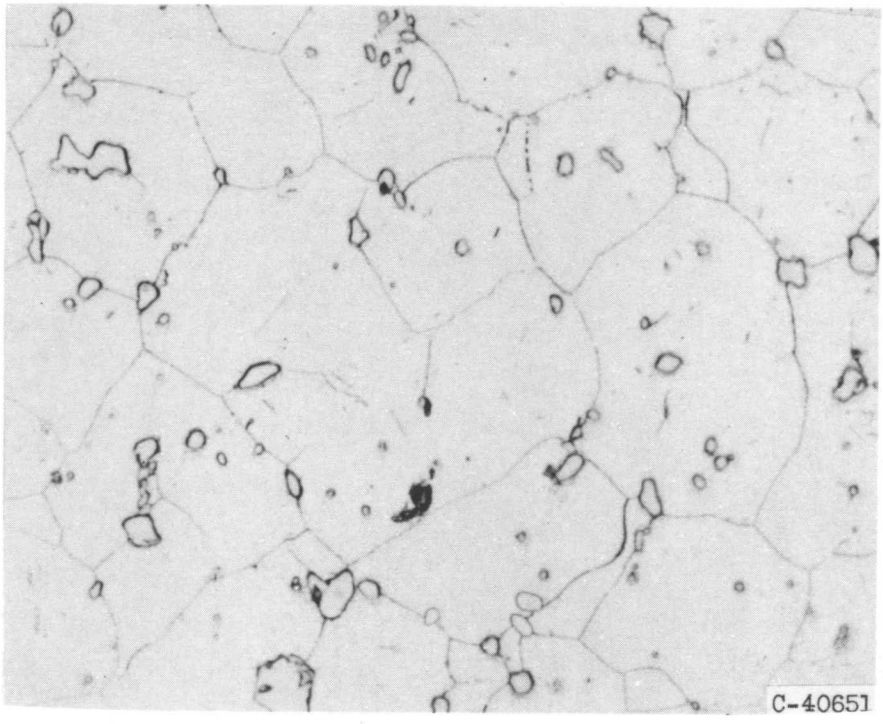
The reasonable assumption has been made that for alloy S-816, reduction in creep resistance is evidence of reduction in stress-rupture strength (see fig. 3). The higher creep rates for blade groups overtemperatured between 1550° and 2000° F indicate that the damage increased with increasing temperature. The changes in microstructure correlate well with the changes in creep rates; the microstructures of figures 5 to 9 show increasing spheroidization or agglomeration of precipitates with

Figure 5. - Microstructure of S-816 after 15 minutes at 1550° F. Etchant, 25 percent aqua regia plus 75 percent glycerol.

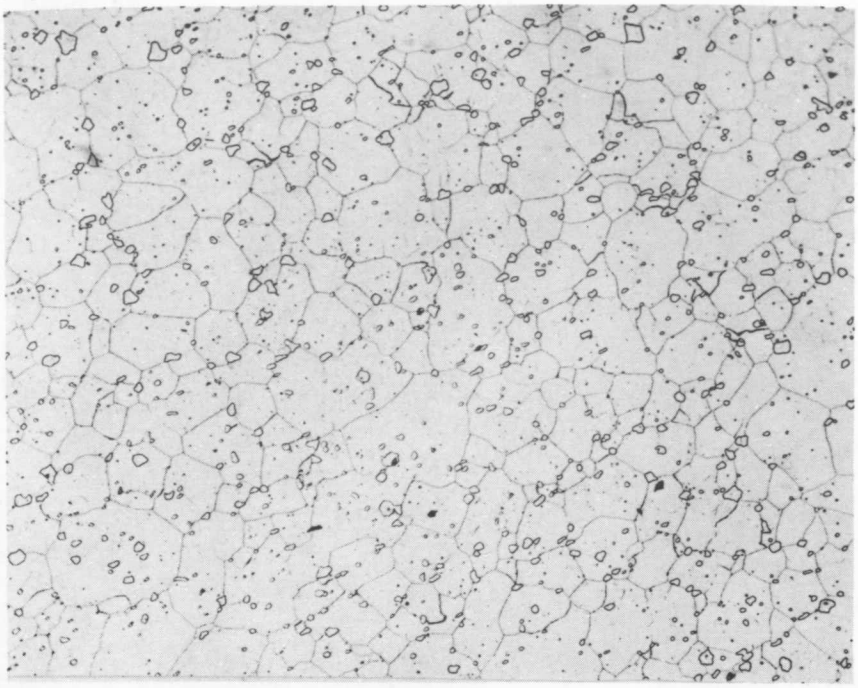
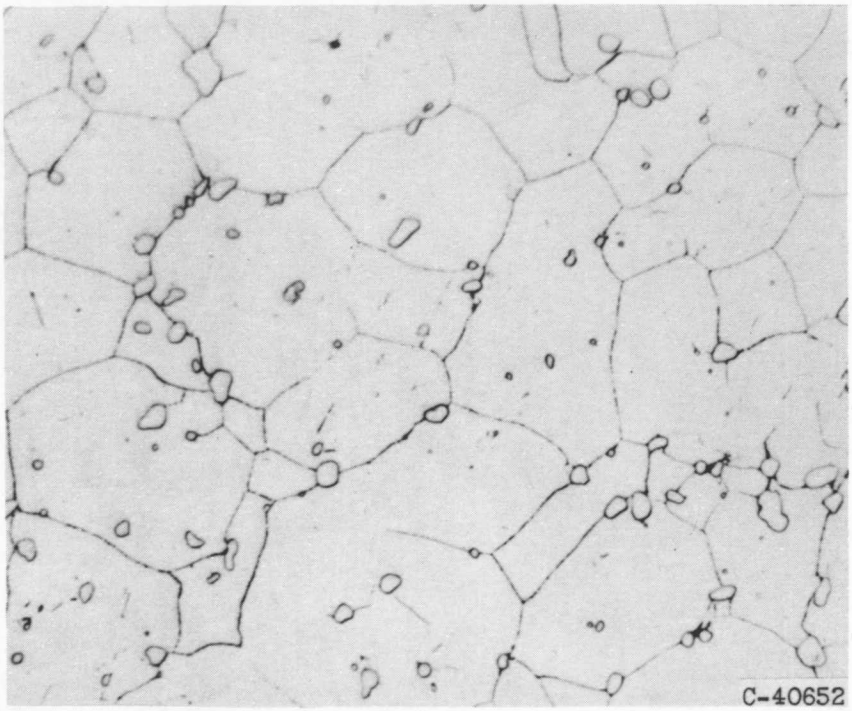
Figure 6. - Microstructure of S-816 after 15 minutes at 1700° F. Etchant, 25 percent aqua regia plus 75 percent glycerol.

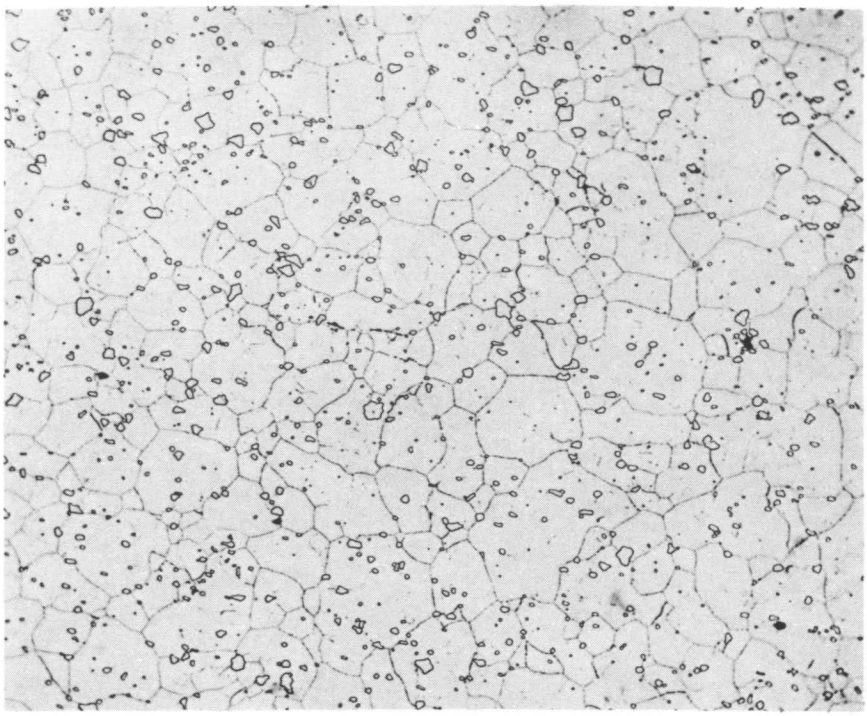
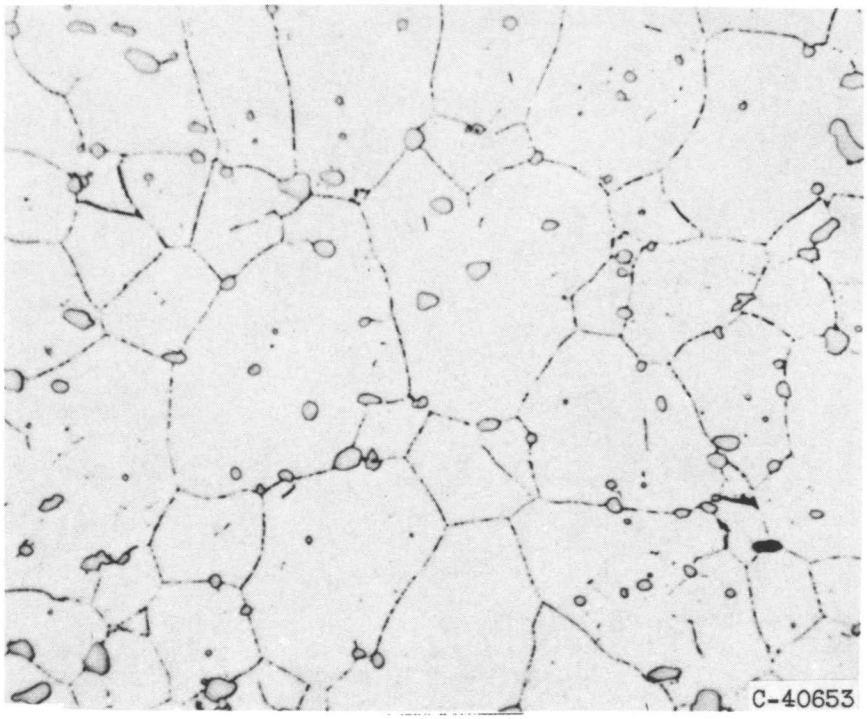
Figure 7. - Microstructure of S-816 after 15 minutes at 1800° F. Etchant, 25 percent aqua regia plus 75 percent glycerol.

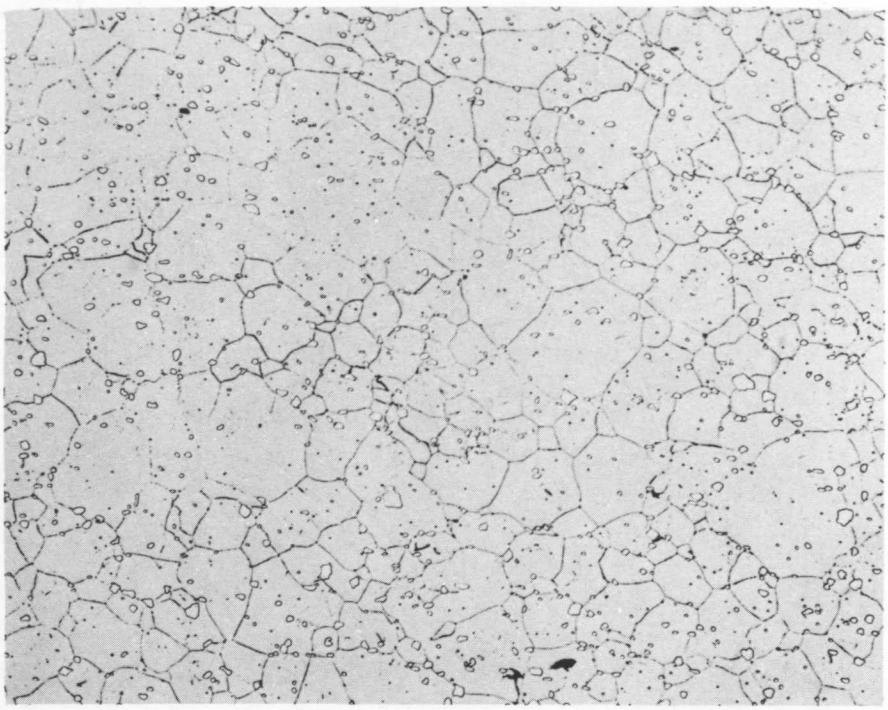
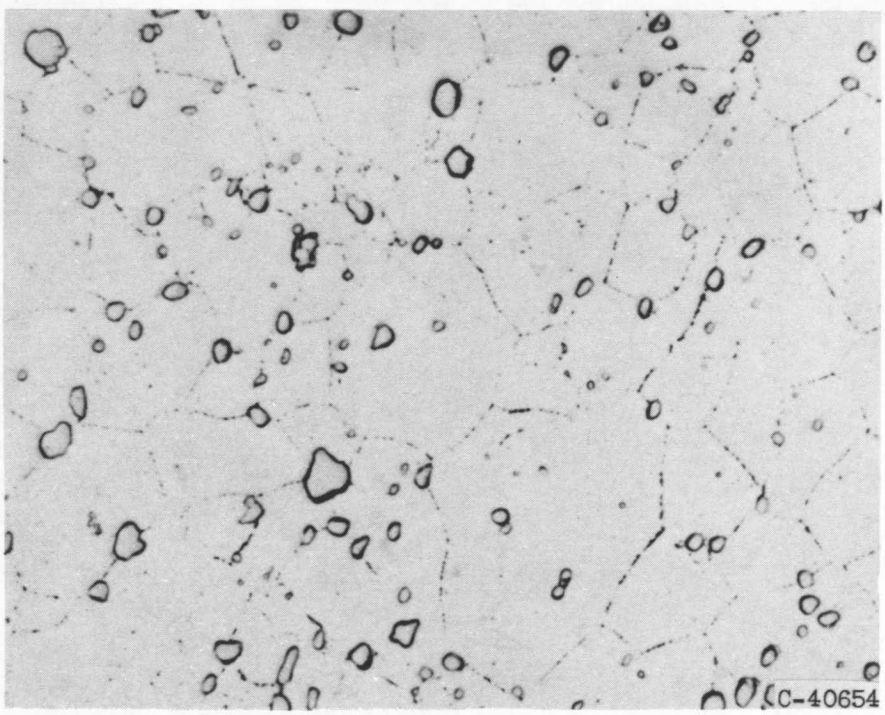
Figure 8. - Microstructure of S-816 after 15 minutes at 1900° F. Etchant, 25 percent aqua regia plus 75 percent glycerol.

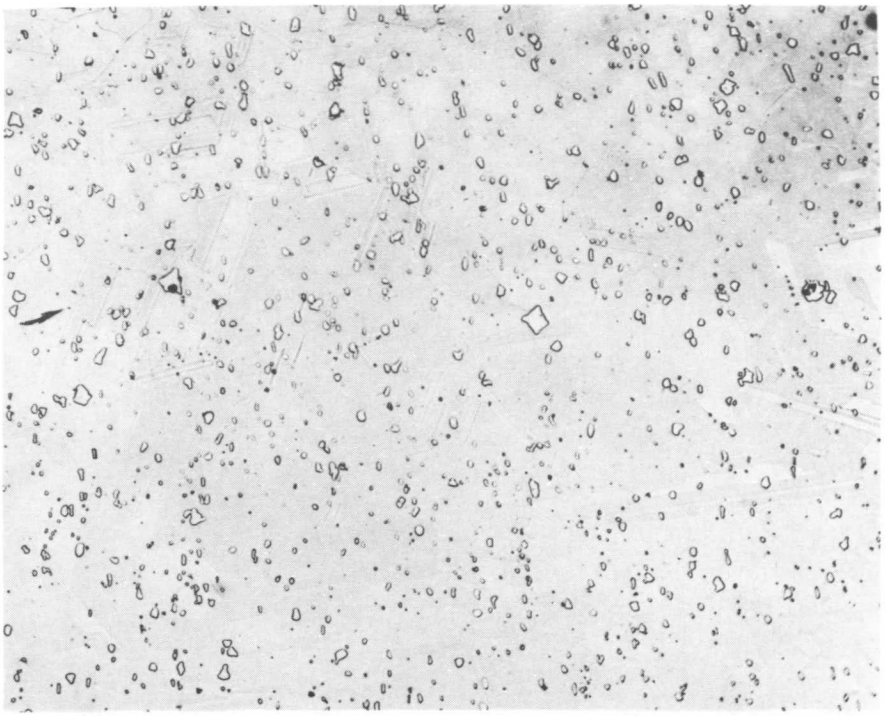
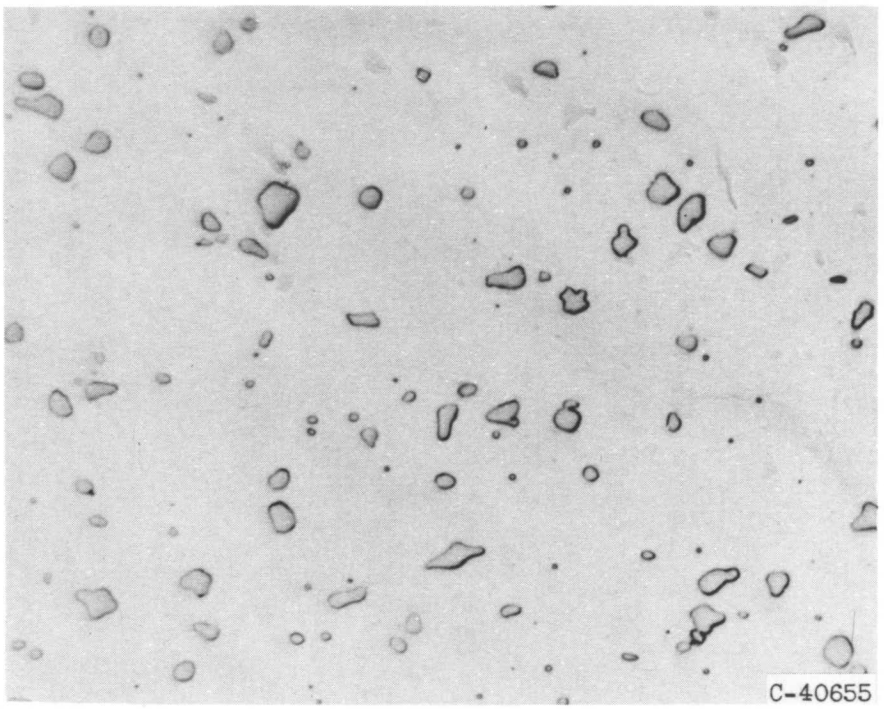
Figure 9. - Microstructure of S-816 after 15 minutes at 2000° F. Etchant, 25 percent aqua regia plus 75 percent glycerol.

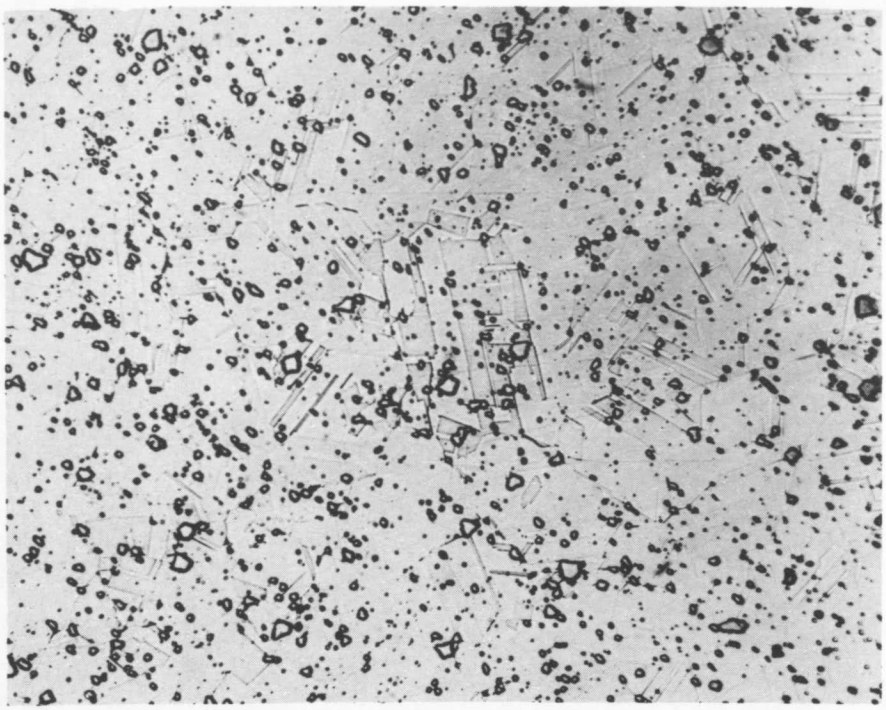
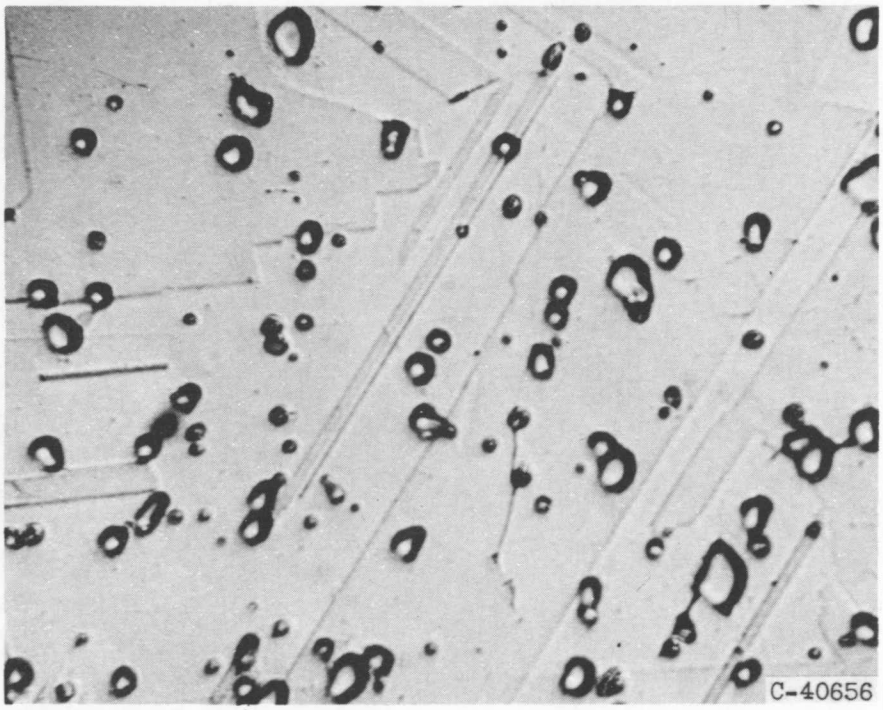
Figure 10. - Microstructure of S-816 after 15 minutes at 2150° F. Etchant, 25 percent aqua regia plus 75 percent glycerol.

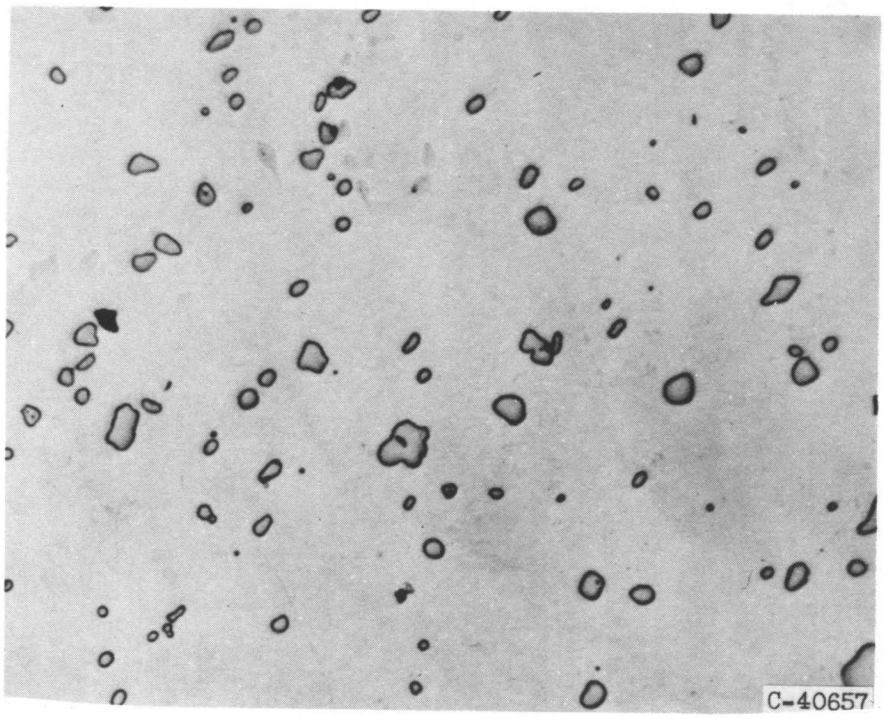
(b) X1000.

Figure 11. - Microstructure (over etched to emphasize grain boundaries) of S-816 after 15 minutes at 2150° F. Etchant, 10 percent hydrochloric acid.

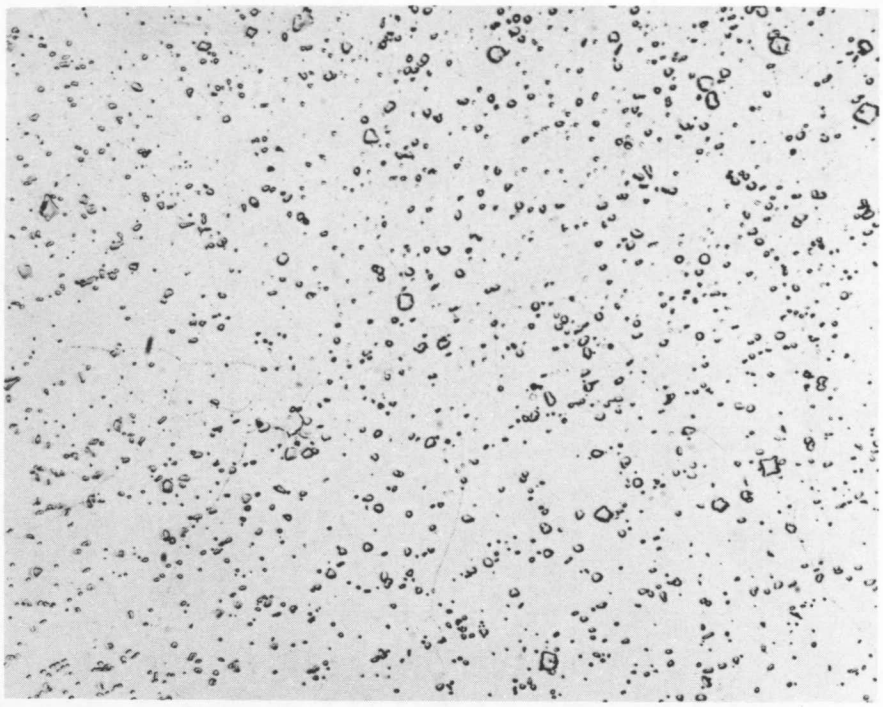
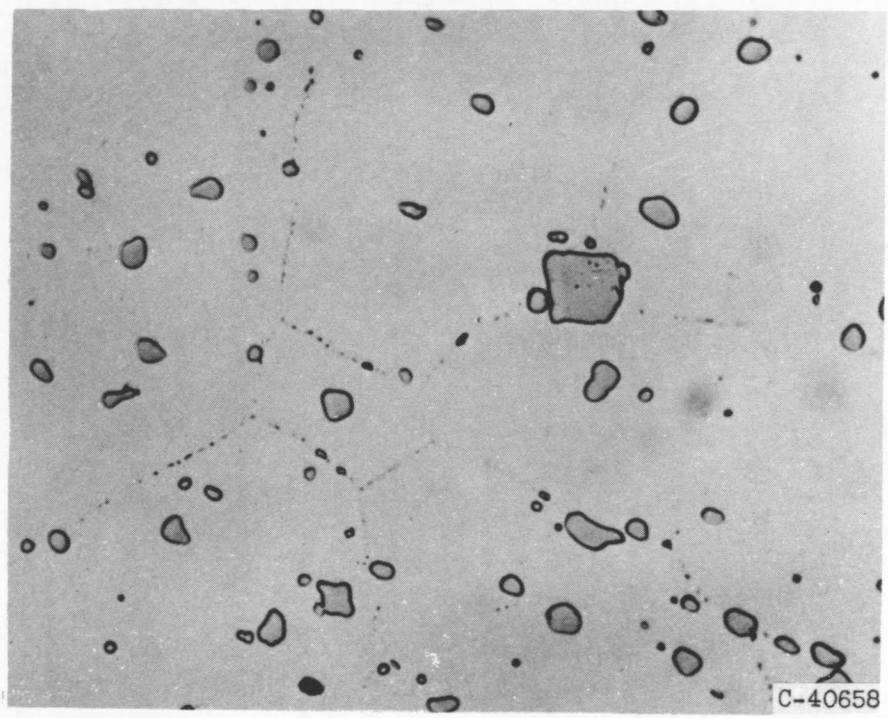
Figure 12. - Microstructure of S-816 after 15 minutes at 2350° F. Etchant, 25 percent aqua regia plus 75 percent glycerol.

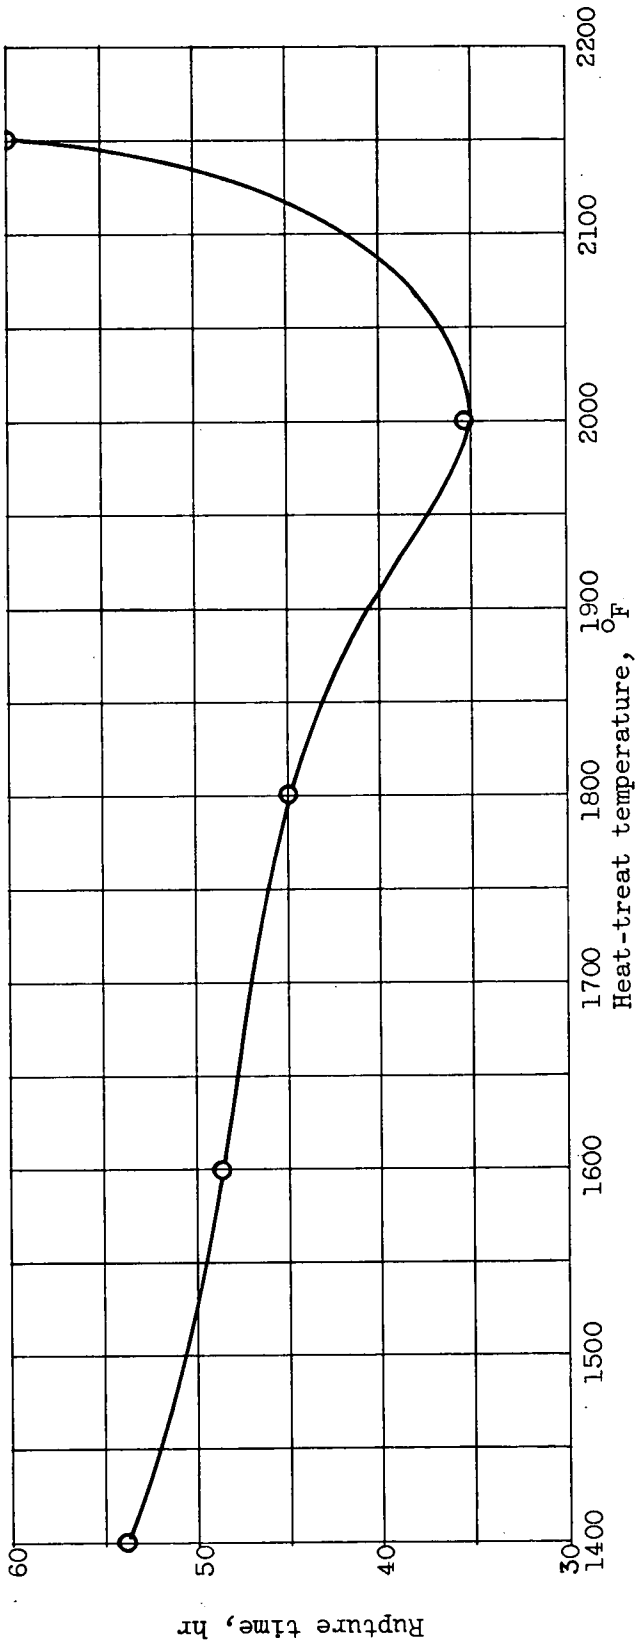
It must not be concluded, however, that properties of the overtemperatured material were not affected. The higher creep rates of some of the groups of buckets would indicate that the stress-rupture strength of these groups was reduced. Investigations conducted by several manufacturers have shown that overtemperaturing specimens can reduce the stress-rupture strength of S-816. For example, figure 14 shows that overtemperaturing for 4 hours at temperatures between 1800° and 2000° F drastically reduces 1500° F stress-rupture strength (ref. 7). Unpublished data obtained at the Lewis laboratory corroborated some of this work; test specimens cut from buckets overtemperatured in service have shown decreased stress-rupture strengths. Still further evidence of damage to stress-rupture strength has been found at the Engineering Research Institute, University of Michigan, where cyclic treatments were studied.

Figure 14. - Influence of heat-treat temperature on stress-rupture life of S-816 alloy at 25,000 psi and 1500° F. Heat treatment: 1 hour at 2150° F, water quench; 16 hours at 1400° F, air cool; 4 hours at temperatures shown. (Ref. 7)
